## VISUAL INSPECTION REPORT • SAMPLE

# Chimney stack & surrounding roof

| Property | Residential bungalow — address withheld in this sample |

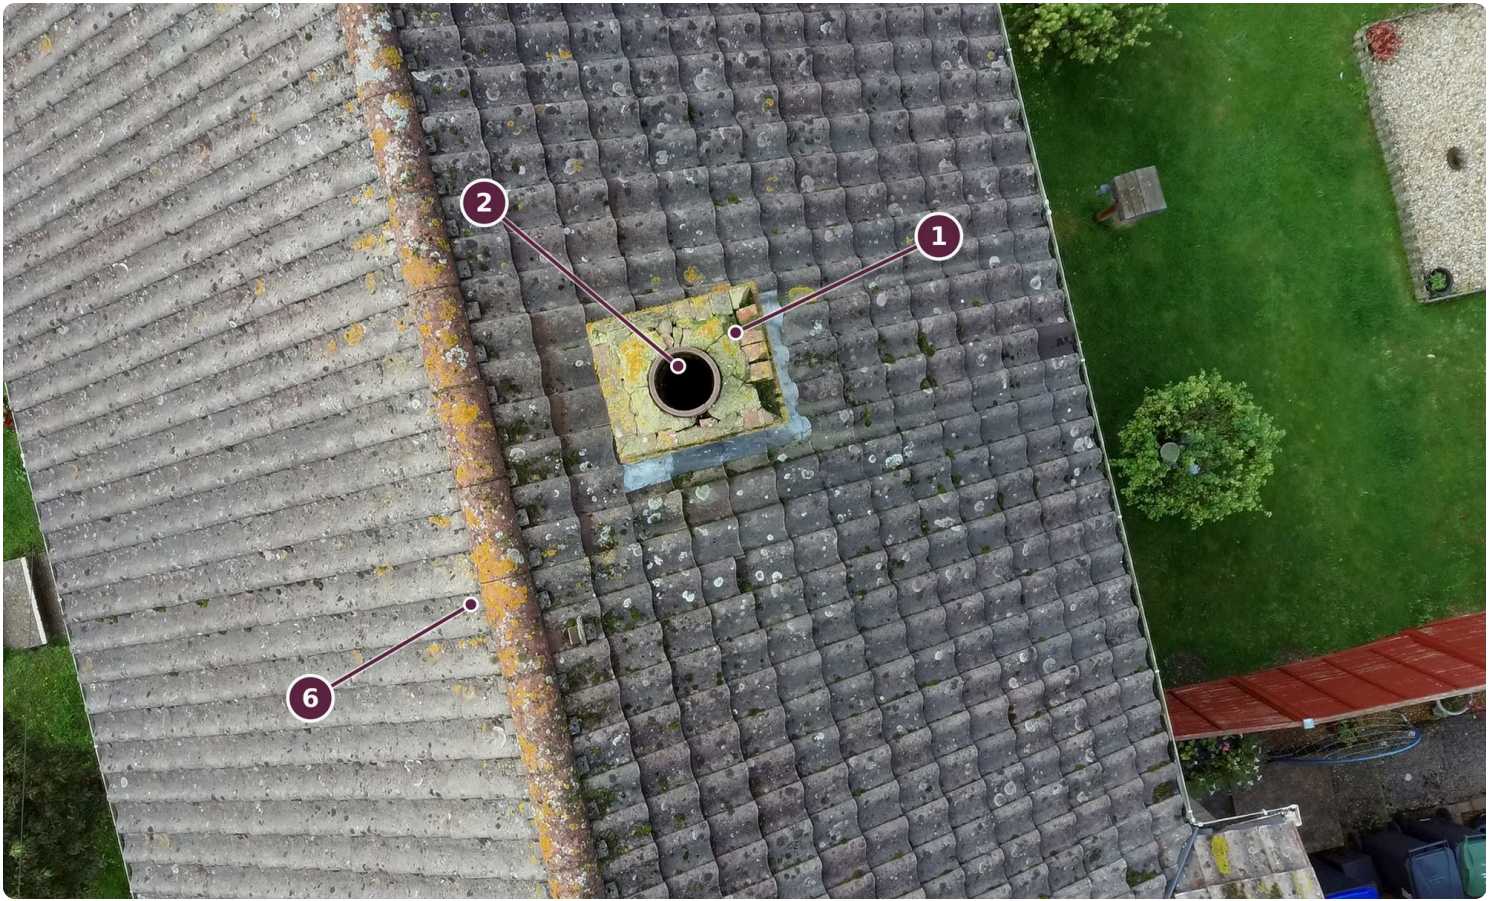
| ELEMENT | WHAT IS VISIBLE | CONDITION |
|---|---|---|
| <b>1</b> <b>Flaunching (mortar cap around the pot)</b><br>Fig. 1 | The cement flaunching is weathered and cracked, with the surface breaking down around the pot and at the edges. Heavy lichen cover. Cracked flaunching lets water into the top of the stack and can eventually let the pot work loose. | Attention advised |
| <b>2</b> <b>Chimney pot</b><br>Fig. 1 | Single clay pot, open and uncapped — no cowl, cap or bird guard fitted. Rain and birds can enter the flue directly. The pot itself sits upright and appears sound from the air. | Monitor |
| <b>6</b> <b>Roof covering around the stack</b><br>Fig. 1 | Concrete interlocking tiles with widespread moss and lichen, heaviest along the ridge line. No slipped, cracked or missing tiles are visible in the inspected area. Moss will keep shedding into the gutters, which is a maintenance point rather than a defect. | No immediate action |

**Fig. 1 — directly overhead.** The view you cannot get from a ladder. **1** cracked, weathered flaunching around the pot · **2** open pot, no cowl or bird guard · **6** moss and lichen across the tiles and ridge.

- 1. Have a roofer quote for re-flaunching the crown and repointing the top courses.** This is the substantive repair, and doing the two together means one access cost. Ask them to confirm the condition of the top courses once up there — if the brick faces have gone too far, rebuilding the top few courses is the right fix.
- 2. Decide what the flue is for, then cap it accordingly.** If the fireplace is unused, a vented cap keeps rain and birds out while letting the flue breathe. If it is in use, fit a cowl and bird guard suited to the appliance. Either is a small job to add to the same visit.
- 3. Remove the vegetation on the crown** as part of the repair — roots in mortar joints accelerate exactly the deterioration seen here.

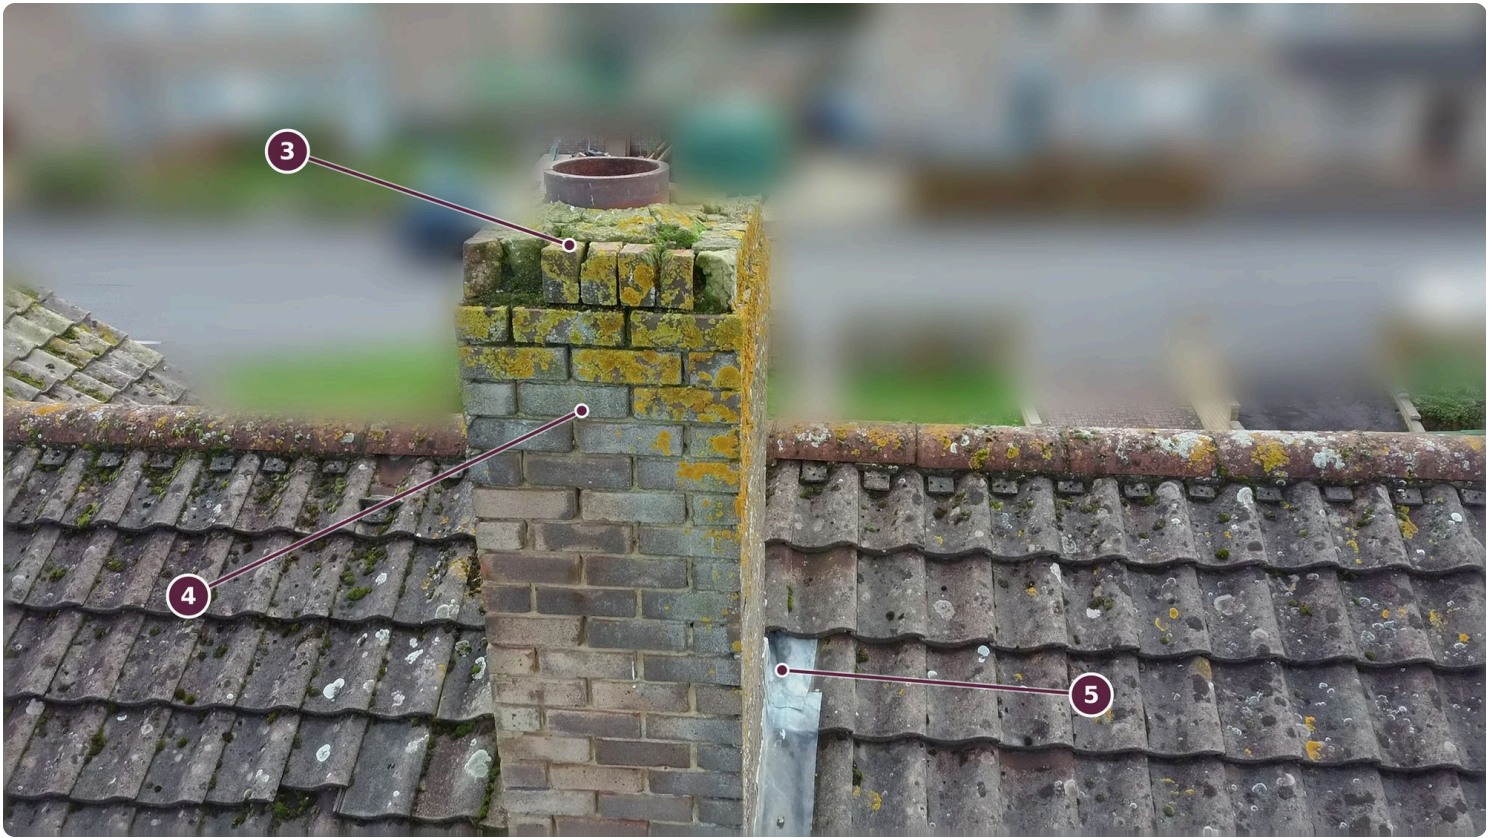
| ELEMENT | WHAT IS VISIBLE | CONDITION |
|---|---|---|
| <b>3</b> <b>Crown brickwork (top courses)</b><br>Fig. 2 & 3 | The top few courses show open, washed-out mortar joints and uneven brick edges, with vegetation rooted in the joints on the crown. This is the most exposed part of the stack and the most weathered. | Attention advised |
| <b>4</b> <b>Stack brick faces</b><br>Fig. 2 & 3 | General weathering and lichen growth on the faces below the crown, with surface erosion to individual bricks — clearest on the rear face, where one brick has lost its face entirely (Fig. 3). The main body of the stack reads as sound and true; the deterioration is concentrated at the top. | Monitor |
| <b>5</b> <b>Lead flashing at the base</b><br>Fig. 2 & 3 | The lead apron and side flashings are aged and oxidised, with the dressing slightly uneven at the corners, but the lead is continuous all round and no staining or ingress marks are visible on the surrounding tiles. | Monitor |

**Fig. 2 — at ridge height, front.** Close pass on the crown: the displaced coping bricks and moss along the open joints are plainly visible. **3** open joints and vegetation in the top courses · **4** weathered brick faces below the crown · **5** aged but continuous lead flashing at the base.

4. **No action needed on the lead flashing or tiles now.** Ask the roofer to re-dress the flashing corners while up there if convenient, and keep gutters cleared given the moss shedding off the roof. Worth re-checking after a hard winter.

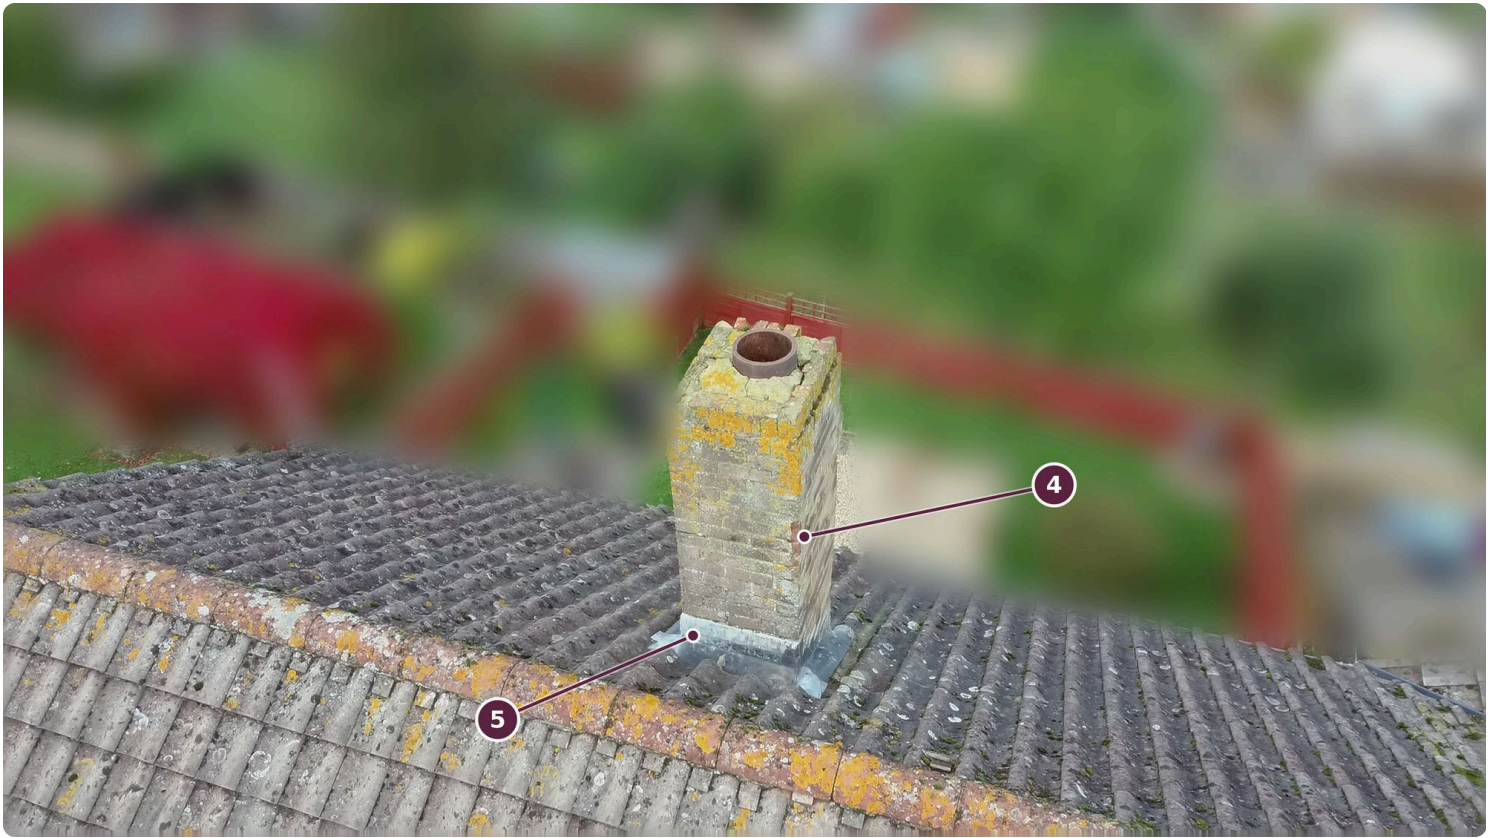
**Fig. 3 — rear elevation.** **4** a brick that has lost its face on the exposed rear corner · **5** the lead apron where the stack meets the roof.
